Technical Note N-1170

HIGH EXPLOSIVE FIELD TEST OF HARDENED ELECTRICAL GENERATORS

R. S. Chapler and J. M. Stephenson

May 1971

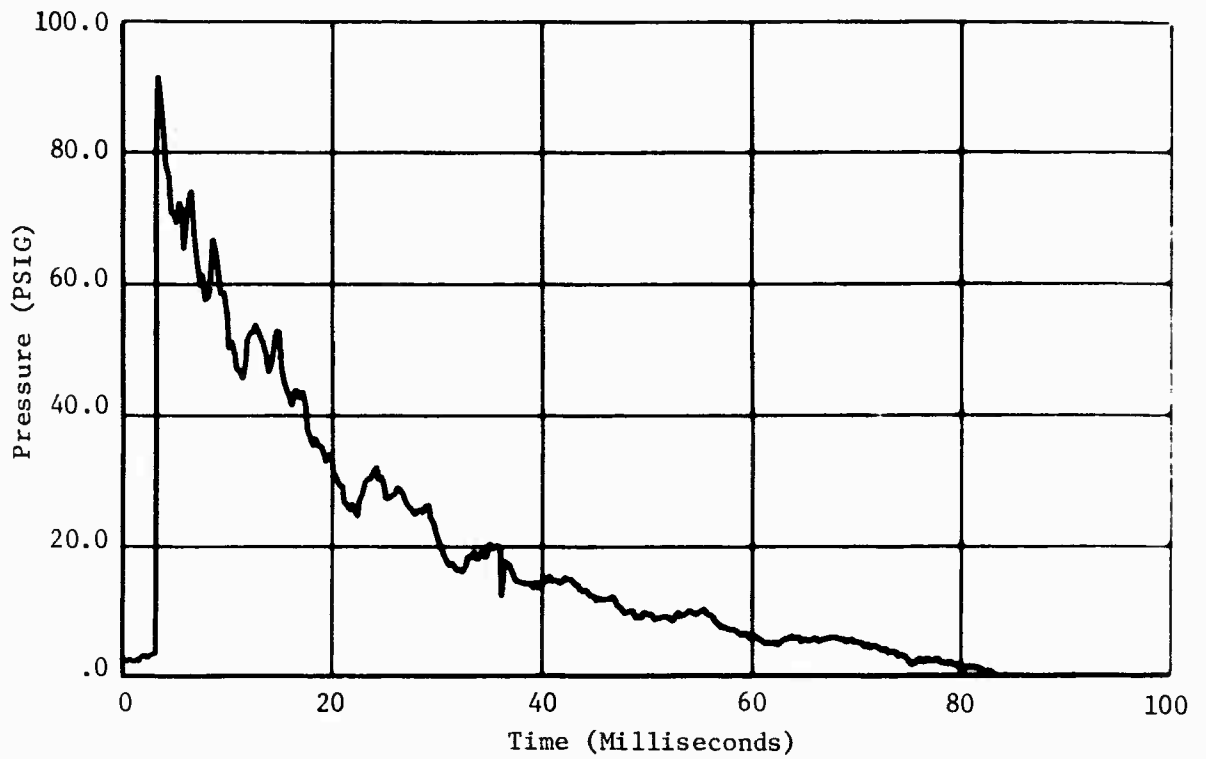
The recorded free field overpressure time history, Figure 8, shows that the peak overpressure was 94 psi. The blast wave arrival time of 69.5 milliseconds and the overpressure positive phase duration of 80.5 milliseconds agreed with predictions by the U. S. Technical Director.

Figure 8. Free field overpressure time history.

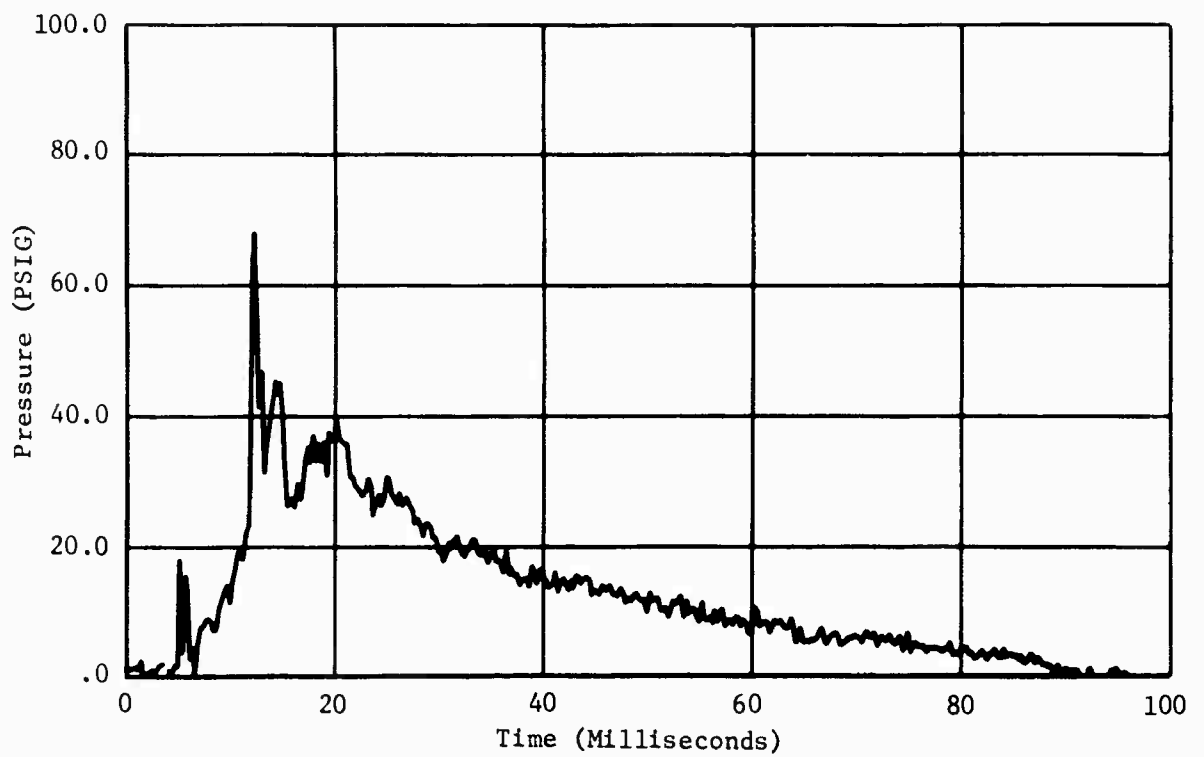
The overpressure within Pit "H", shown in Figure 9, indicated that only limited penetration of the initial shock wave occurred. An initial shock wave of only 22.4 psig was followed by a relatively slow increase to a peak pressure of 68.5 psi in 9 milliseconds. The pressure then decayed slowly to atmospheric pressure in 108 milliseconds. Similarly, in Pit "S", the initial penetrating shock wave was 23.5 psig with a rapid rise to 30.3 psig in 0.2 milliseconds. A subsequent slow increase to a peak pressure of 59.9 psig occurred over the next 10.6 milliseconds. Pressure decay of this peak level to atmospheric then occurred over an 88 millisecond period for a positive phase duration of 99 milliseconds.

Figure 9. Overpressure time history in Pit H.
